**Flood Control Project Maintenance
Levee Inspections**

Maintenance Issue Types Only, Levee Inspection Report By Mile - Fall 2018

Reclamation District No. 0070 Meridian

Waterway	Bank	Unit Miles	Inspection Start/End	Inspector
Unit No. 01 Sutter Bypass	Right	7.92	11/01/2018 11/01/2018	Bob Duffey

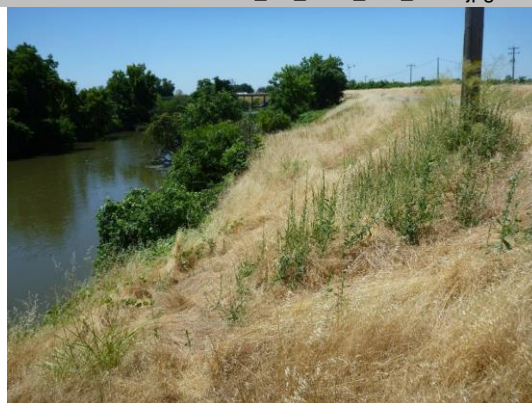
Photo 1 of 3 : LEVAL_FA_2018_154_1686.jpg

LM Start	0.76	Rating **	A/W	Issue No.	36
LM End	0.76	Issue Type +	Ma	Location *	
Category	Supplemental			GPS Latitude/Longitude	
				Start	End
Item	2017 Storm Damage			39.145240 °	39.145240 °
				-121.842650 °	-121.842650 °
DWR ID	DWR_RD0070_01_f_2017_36				
Comment Code					
Inspector Comment					
Levee Evaluation Comments					
Description:					
Site ID No:154					
Site Designation:RD 70-03					
Repair Type: Erosion					
Rating:Area of Concern					
Field Date:7/17/2017					
Notes:

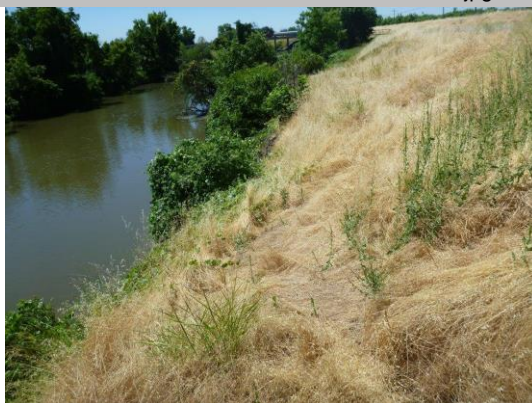
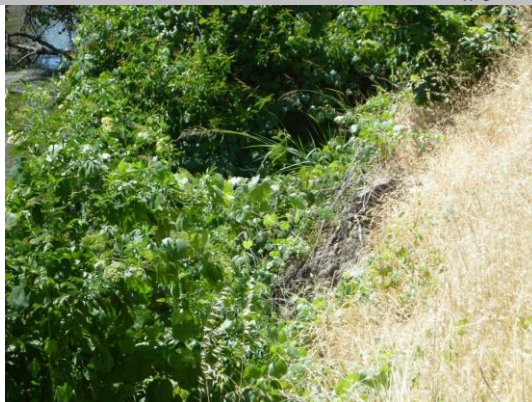
LM Start	0.76	Rating **	A/W	Issue No.	36 (cont)	
LM End	0.76	Issue Type +	Ma	Location *		
Category	Supplemental			GPS Latitude/Longitude		
				Start	End	
Item	2017 Storm Damage			39.145240 °	39.145240 °	
				-121.842650 °	-121.842650 °	
DWR ID	DWR_RD0070_01_f_2017_36					
Comment Code						
Inspector Comment						
Levee Evaluation Comments						
Description:						
Site ID No:154						
Site Designation:RD 70-03						
Repair Type: Erosion						
Rating:Area of Concern						
Field Date:7/17/2017						
Notes:

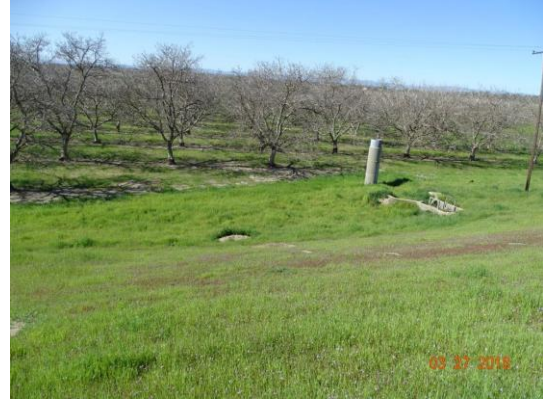
Photo 1 of 1 : FA_2018_RD0070_29_40_20180905_00019.jpg

LM Start	6.57	Rating **	U	Issue No.	40
LM End	6.57	Issue Type +	Ma	Location *	LS
Category	Earthen Levee			GPS Latitude/Longitude	
				Start	End
Item	Animal Control			39.192283 °	39.192283 °
				-121.914388 °	-121.914388 °
DWR ID	DWR_RD0070_01_f_2018_40				
Comment Code					
A3 : No rodents visible, but rodent burrows visible; need to backfill and compact or grout burrows.					
Inspector Comment					
Repair the rodent holes along the landside slope.

View of rodent holes along the landside slope.

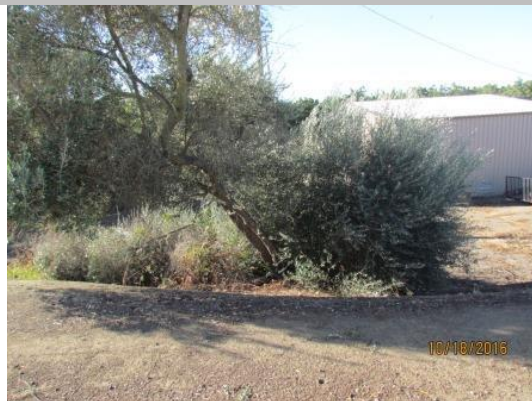
Photo 1 of 1 : FA_2018_RD0070_30_54_20180905_00008.jpg

View of the trees blocking visibility.

LM Start	4.95	Rating **	M	Issue No.	54
LM End	4.95	Issue Type +	Ma	Location *	LS
Category	Earthen Levee			GPS Latitude/Longitude	
				Start	End
Item	Trim / Thin Trees			39.142016 °	39.142016 °
				-121.926214 °	-121.926214 °
DWR ID	DWR_RD0070_02_f_2016_54				
Comment Code					
T1 : Trim trees to at least five feet above ground level.					
Inspector Comment

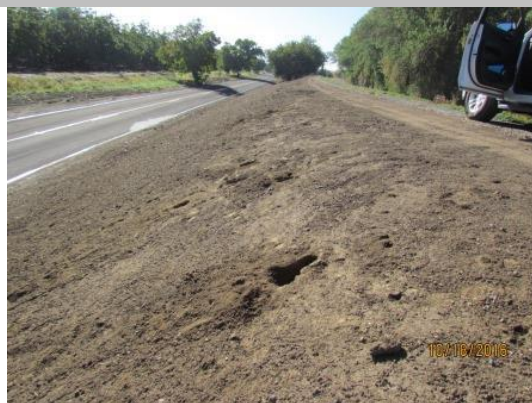
Photo 1 of 1 : FA_2018_RD0070_30_61_20180905_00012.jpg

View of the rodent holes along the landside slope.

LM Start	9.28	Rating **	M	Issue No.	61
LM End	9.28	Issue Type +	Ma	Location *	LS
Category	Earthen Levee			GPS Latitude/Longitude	
				Start	End
Item	Animal Control			39.107285 °	39.107285 °
				-121.900753 °	-121.900753 °
DWR ID	DWR_RD0070_02_f_2016_61				
Comment Code					
A3 : No rodents visible, but rodent burrows visible; need to backfill and compact or grout burrows.					
Inspector Comment

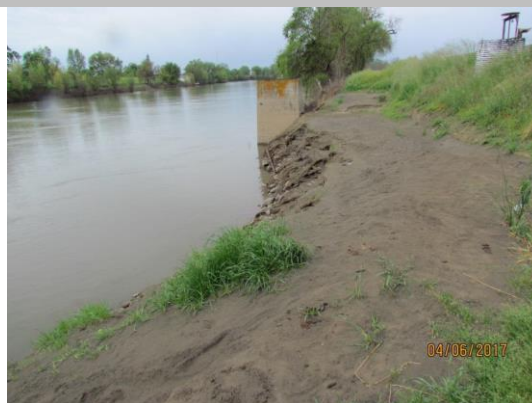
Photo 1 of 1 : FA_2018_RD0070_30_72_20180905_00016.jpg

View of the erosion along the waterside slope.

LM Start	13.82	Rating **	A/W	Issue No.	72
LM End	13.82	Issue Type +	Ma	Location *	WS
Category	Earthen Levee			GPS Latitude/Longitude	
				Start	End
Item	Erosion / Bank Caving			39.068370 °	39.068370 °
				-121.862763 °	-121.862763 °
DWR ID	DWR_RD0070_02_s_2017_72				
Comment Code					
E2 : Schedule repair of erosion site prior to the next inspection.					
Inspector Comment					
Repair the erosion along the waterside slope.

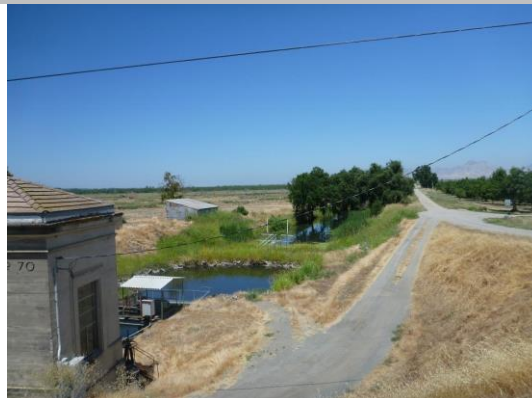
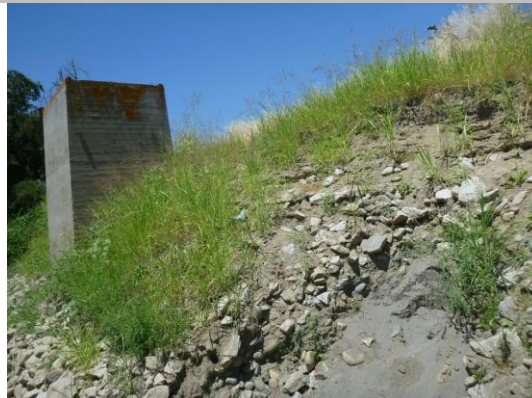
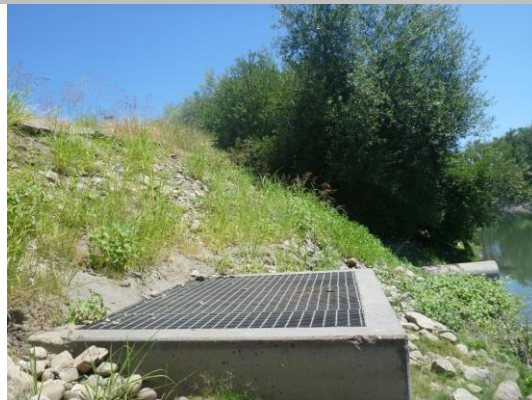
LM Start	13.83	Rating **	A/W	Issue No.	75
LM End	13.83	Issue Type +	Ma	Location *	
Category	Supplemental			GPS Latitude/Longitude	
				Start	End
Item	2017 Storm Damage			39.068190 °	39.068190 °
				-121.862700 °	-121.862700 °
DWR ID	DWR_RD0070_02_f_2017_75				
Comment Code					
Inspector Comment					
Levee Evaluation Comments					
Description:					
Site ID No:152					
Site Designation:RD 70-01					
Repair Type: Erosion					
Rating:Area of Concern					
Field Date:7/17/2017					
Notes: bank slope erosion around a drainage pipe/box

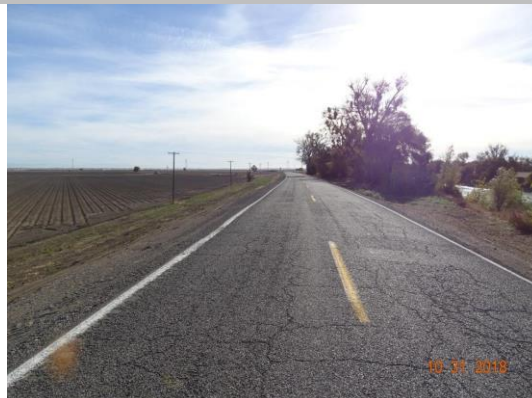
Photo 1 of 1 : FA_2018_RD0070_30_55_20181102_00127.jpg

LM Start	15.11	Rating **	A	Issue No.	55
LM End	15.11	Issue Type +	Ma	Location *	LS
Category	Earthen Levee			GPS Latitude/Longitude	
				Start	End
Item	Vegetation			39.067052°	39.067052°
				-121.842738°	-121.842738°
DWR ID	DWR_RD0070_02_f_2018_55				
Comment Code					
V1 : Control annual grass and weeds on the levee slopes and easements.					
Inspector Comment					
There was no vegetation on both slopes.

View of no vegetation on both slopes.
